# Building Inspection Report

## Sample Commercial Inspection Report

Professional Property Inspection Consultants  
4857 Winterset Drive  
Columbus, OH 43220  
(614) 459-5941

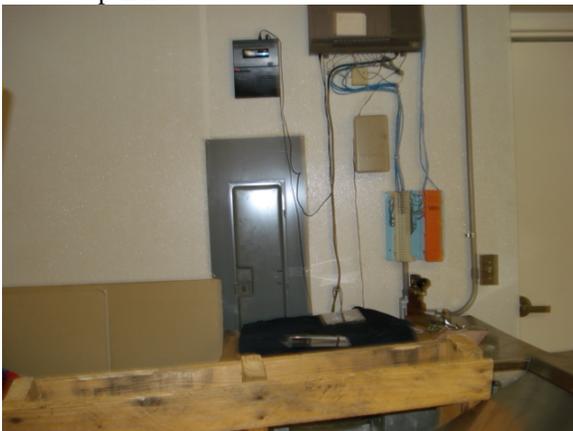
- 4.2.1 While detailed load calculations were not performed, no problems are suspected with the service capacity. The service should be adequate for the present usage.
- 4.2.2 There is inadequate clearance in front of the panel box at the Dominos. There should be 36 inches in front of the panel.

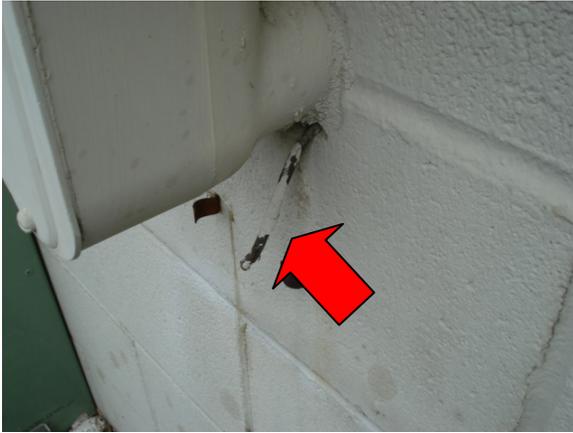
- 4.2.3 The grounding electrode conductors have been cut at the exterior. This may have been vandalism to steal the copper. This is a potentially dangerous situation that should be repaired immediately.

Recommendations		Costs	Time Frame
4.3.1	Repair grounding electrode conductor	Minimal	Immediate
4.3.2	Bollards should be installed to protect transformers from impact	Minimal	Immediate

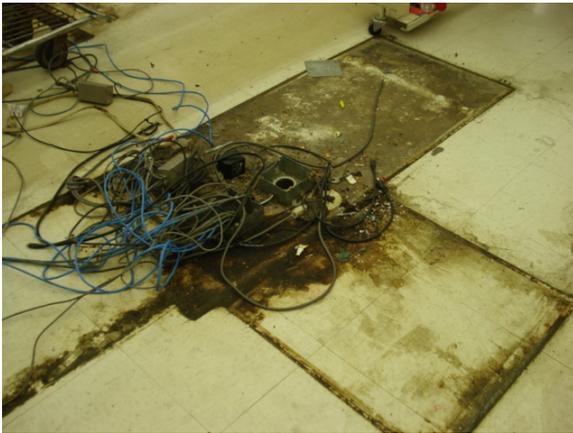
4.2.4 Ongoing remodeling work is being done at the grocery store. Wiring for refrigeration and lighting is being relocated.

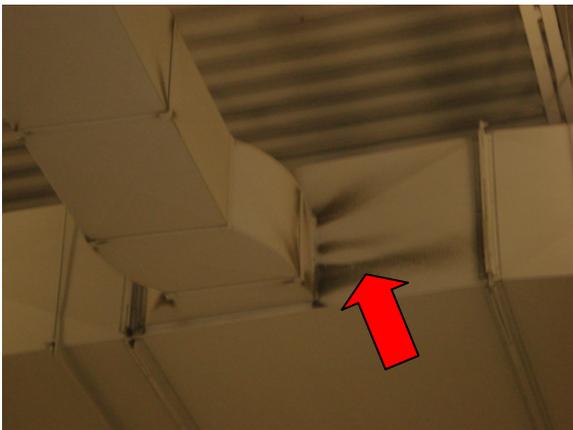
- 5.2.4 It was not feasible to observe the units in operation during the heating mode.
- 5.2.5 The gas lines are corroded and need repainting.  
Standard metal b-vents are supplied for the warehouse units and are in satisfactory condition.
- 5.2.6 The heating distribution appears adequate in most areas. Some pressurization issues were observed showing evidence of ductwork leakage. Balancing of the system may be required.

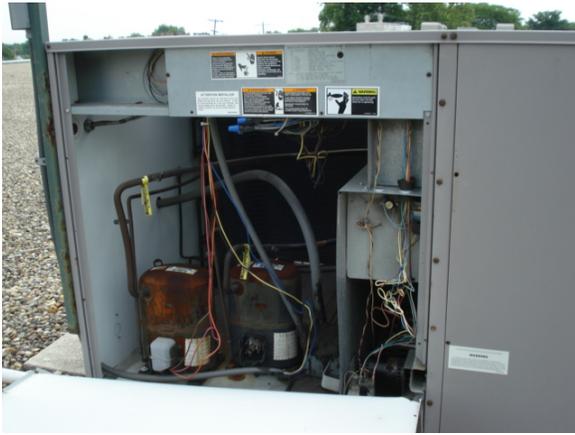
- 5.2.7 The roof top unit over the grocery store labeled RTU 2 appears inoperative and may require replacement.

Recommendations		Costs	Time Frame
5.3.1	Replace Rooftop Unit	\$6,000	Immediate

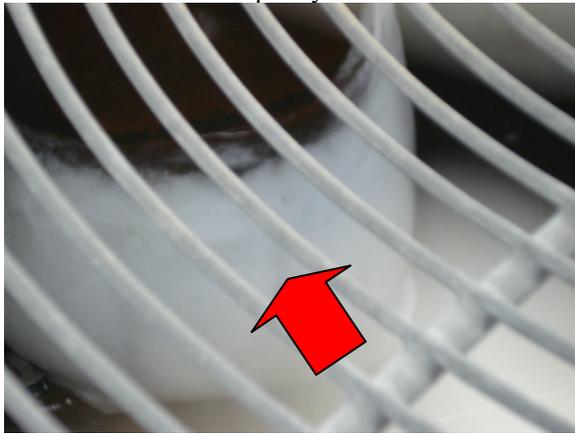
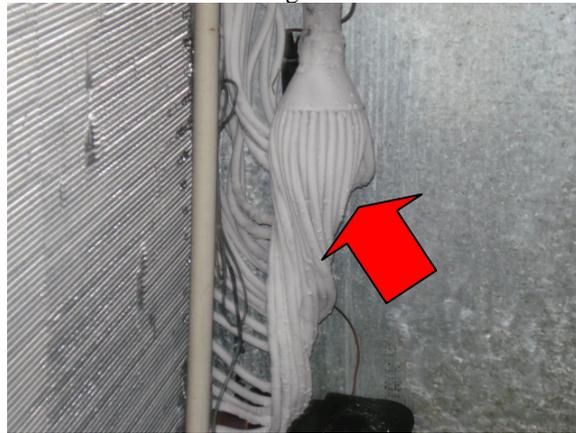
6.2.2 Several windows were noted with ice on the compressors. This generally indicates low refrigerant. Ice was also noted at the capillary tubes of RTU-1. Bubbles were observed in the site glass which indicate low refrigerant.

Recommendations		Costs	Time Frame
6.3.1	Service all Rooftop Units	\$3,000 - \$4,000	Immediate

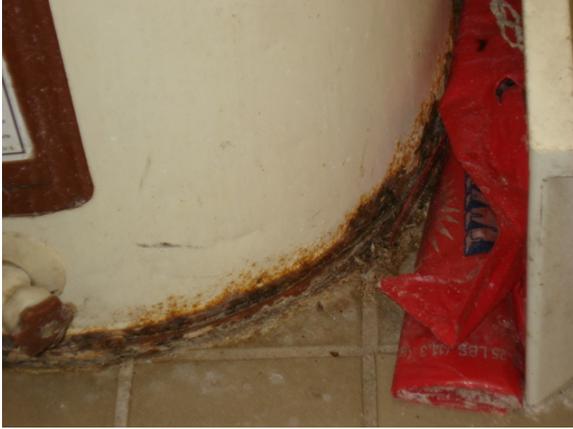
- 8.2.1 No major deficiencies were noted in the plumbing system during the assessment. The location of the main water line to the property was not determined.
- 8.2.2 Some corrosion was observed at the water heater at the Doninos unit.

Recommendations		Costs	Time Frame
8.3.1	Replace existing water heater	Minor	1 year

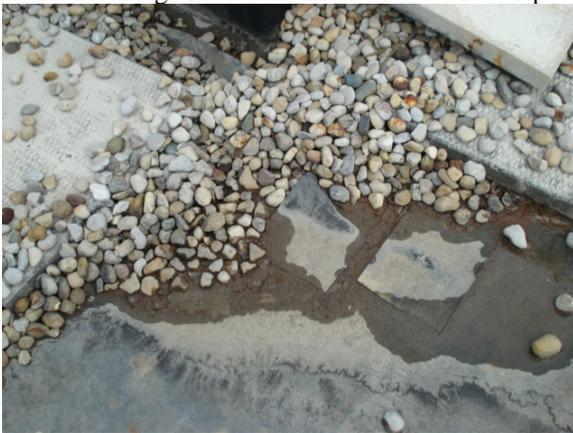
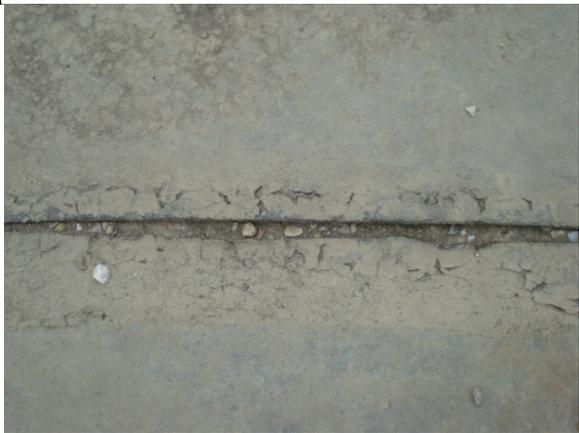
- 9.2.1 The ballast covered EPDM membrane roof cover appears to be in serviceable condition. There is evidence of leakage in several areas and evidence of past repairs.

Recommendations		Costs	Time Frame
9.3.1	Repair existing roof leaks	\$4000-\$6,000	Immediate
9.3.2	Re-roof the entire building (approximately 35,000 s.f.)	Over \$150,000	8-10 years
9.3.3	Install walkway pavers to equipment	\$1,000-\$2,000	Immediate

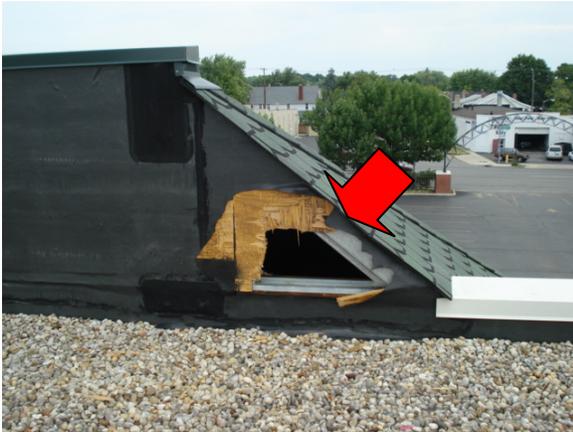
11.2.2 A damaged section was noted at the rear of the front grocery store façade. This is the source of leaks at the front office.

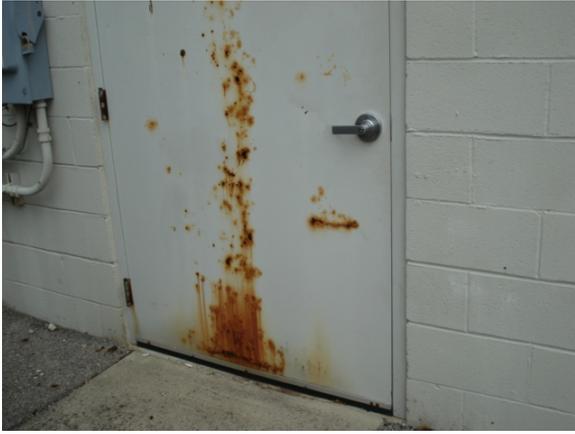
11.2.3 The rear entry door to the vacant unit is rusted and should be replaced. The remaining exterior doors are in satisfactory condition.

Recommendations		Costs	Time Frame
11.3.1	Replace rear service door	\$1000-\$2000	1 year
11.3.2	Install Guards at service platform	\$1500-\$2500	Immediate

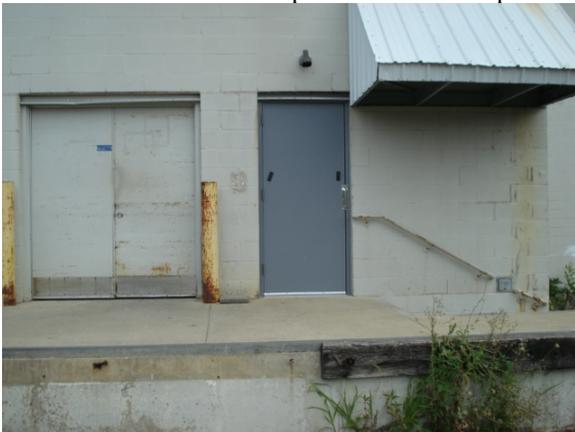
11.2.8. Guards should be present at elevated platforms.
