# Building Inspection Report

## Sample Commercial Inspection Report

Professional Property Inspection Consultants  
4857 Winterset Drive  
Columbus, OH 43220  
(614) 459-5941

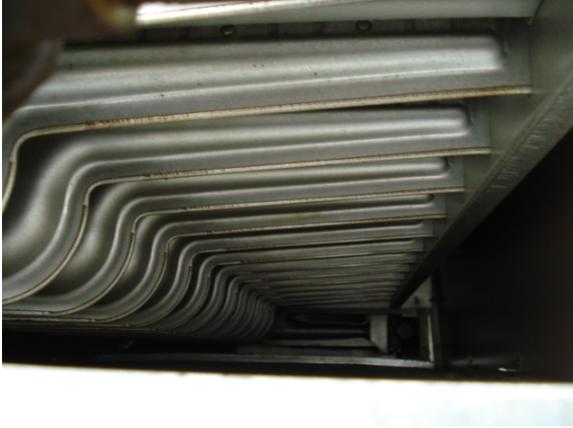
- 5.2.1 While detailed heat loss calculations were not performed, no problems are suspected with the heating capacity.
- 5.2.2 The rooftop units are all estimated at 11 years old which is the age of the building.
- 5.2.3 While it is impossible to predict with certainty when a heat exchanger will fail, the average life for heating equipment of this type is 15 to 20 years. Heat exchangers were not accessible for visual inspection.

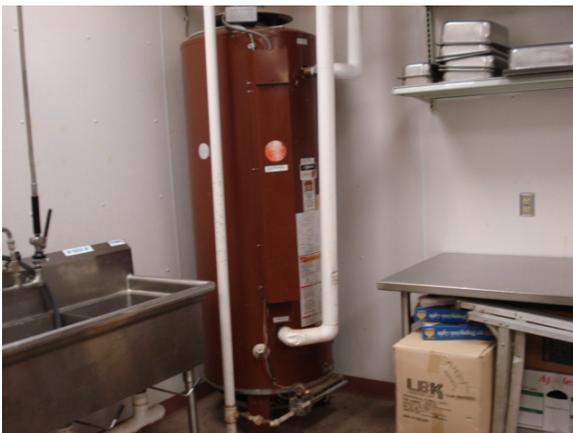
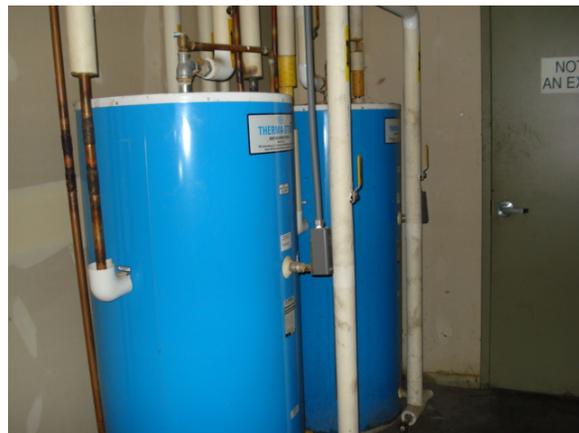
There is a 100 gallon gas fired water heater in the grocery store.

Two 114 gallon Thermo-Stor heat recovery units were located at the mechanical area of the grocery. These units recover heat from the cooling system to heat water.

- 8.2.1 No major deficiencies were noted in the plumbing system during the assessment. The location of the main water line to the property was not determined.
- 8.2.2 Some corrosion was observed at the water heater at the Doninos unit.

Recommendations		Costs	Time Frame
8.3.1	Replace existing water heater	Minor	1 year

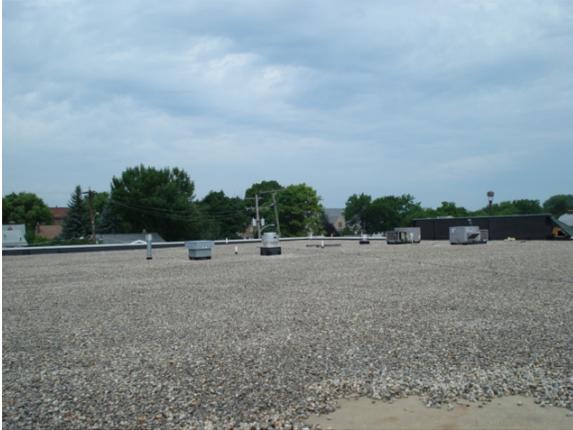
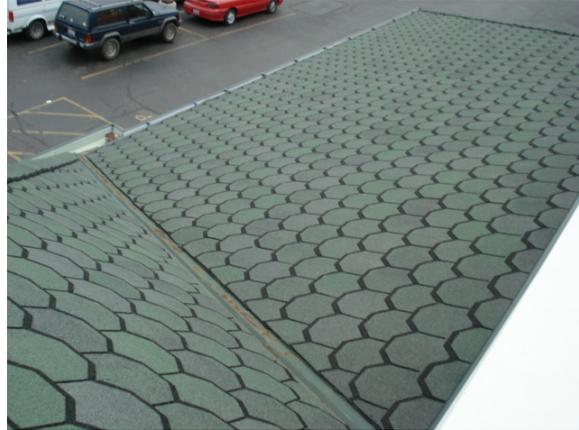
The flat roof is covered by a single-ply EPDM rubber membrane (See photos above) The membrane is covered by a large-stone ballast.

- 9.2.1 The ballast covered EPDM membrane roof cover appears to be in serviceable condition. There is evidence of leakage in several areas and evidence of past repairs.

Recommendations		Costs	Time Frame
9.3.1	Repair existing roof leaks	\$4000-\$6,000	Immediate
9.3.2	Re-roof the entire building (approximately 35,000 s.f.)	Over \$150,000	8-10 years
9.3.3	Install walkway pavers to equipment	\$1,000-\$2,000	Immediate

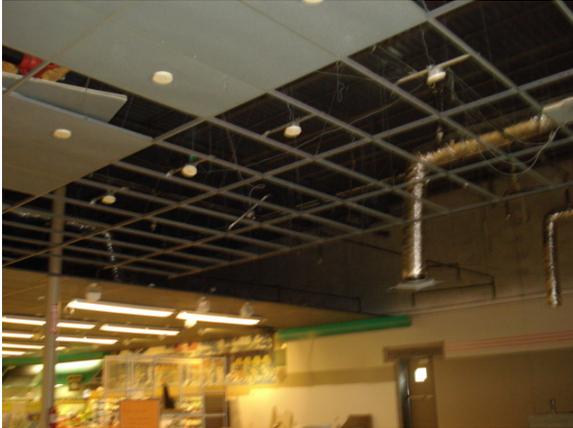
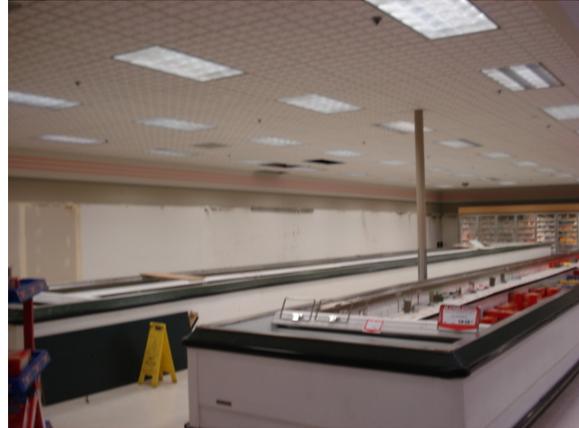
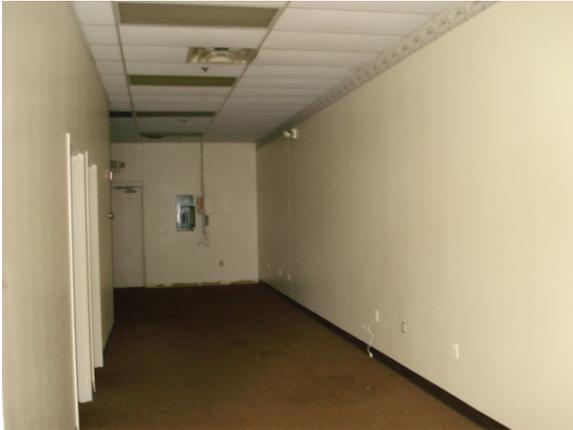
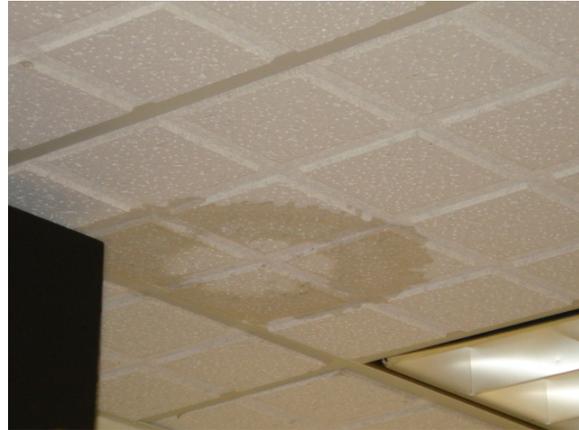
10.2.2. Stains were noted at several drop ceiling panels. The source is considered roof leakage.
