## Evaluating Stucco

*David Tamny  
Registered Architect  
Professional Property Inspection Inc.*

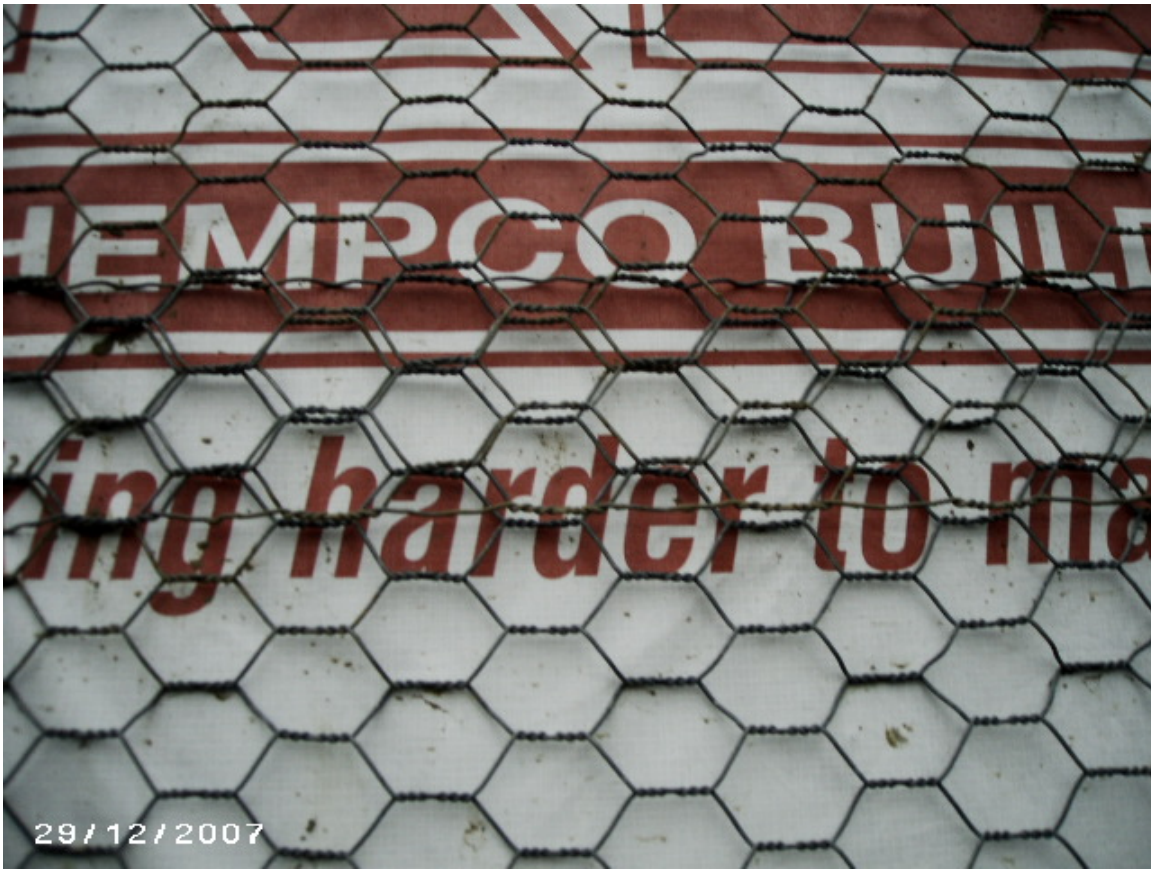
Joseph Lsitburek Ph.D. P.Eng of the Building Science Corporation in his research report titled "Rainwater Management Performance of Newly Constructed Residential Building Enclosures During August and September 2004" shows how Tyvek HomeWrap actually will chemically bond with the stucco. On pg. 13 he states "There appear to be significant performance issues with WRB's (water resistive barriers) relating to manufacture, testing and approval. All plastic housewraps and some building papers tend to bond to stucco renderings thereby negating drainage. Additionally, many plastic housewraps loose their water repellency when in contact with sheathing and stucco renderings."

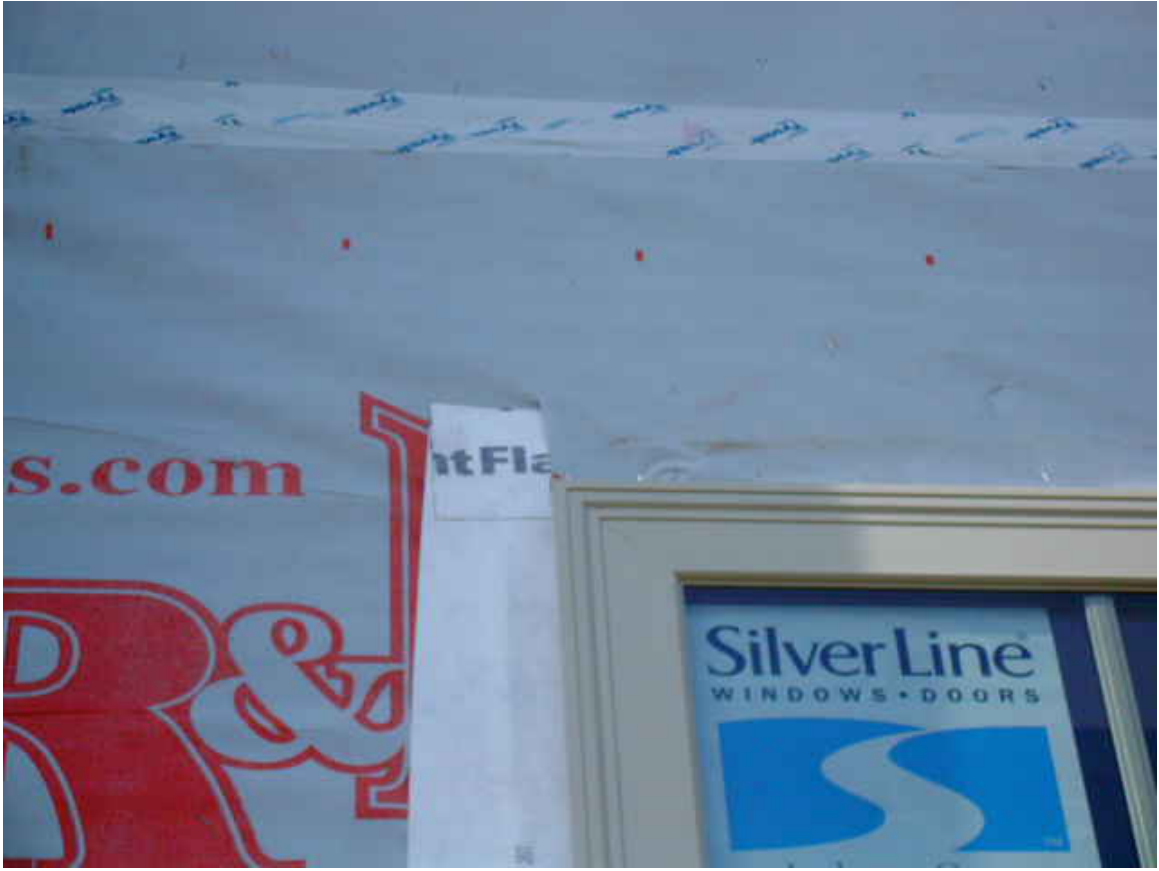
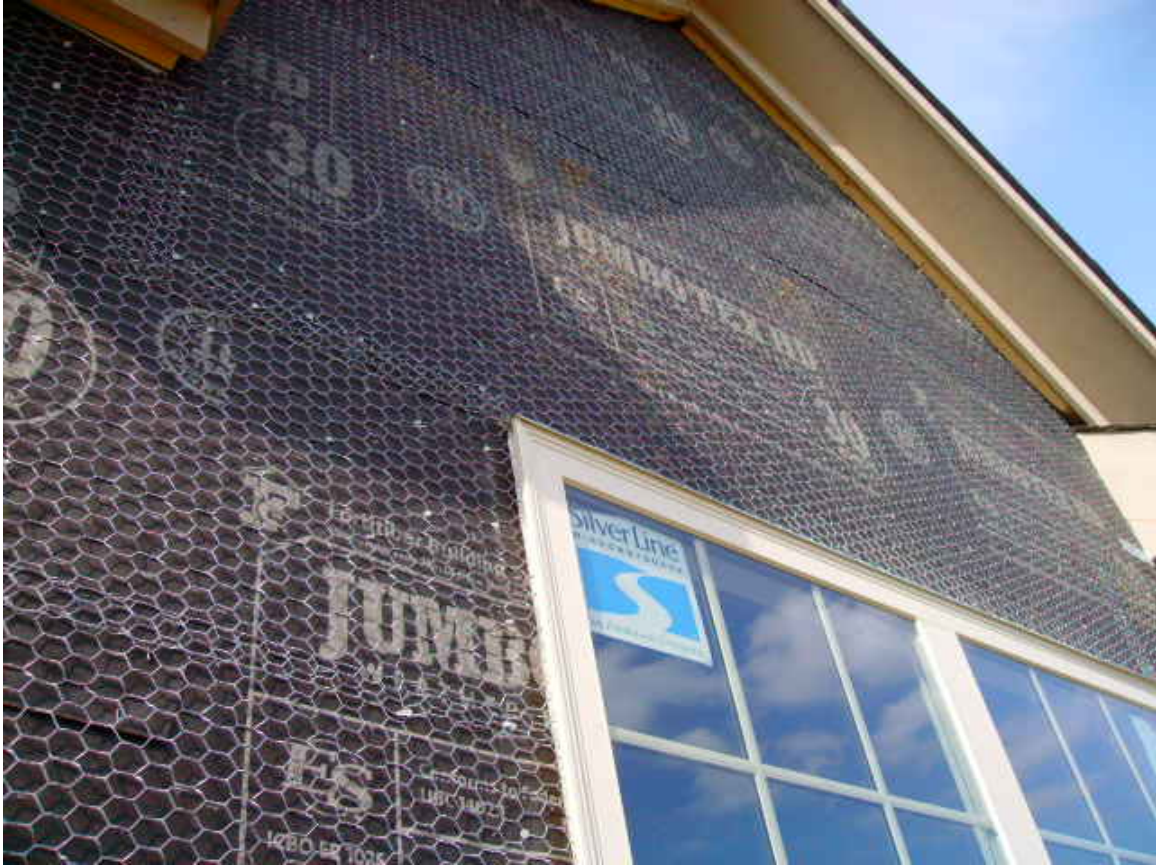
Typically windows are installed by nailing the integral flange and nailing fin to the framing on the exterior of the sheathing. If the windows are not properly flashed with flashing tape and integrated into the housewrap and water resistive barrier water will drain down the window frames in sufficient quantities to saturate the sheathing. Below is a proper installation of Tyvek and flashing tape around a newly installed window. Building paper and wire lath is then installed over the properly flashed window.

This installation insures that water running along the frame will drain down the drainage plane as intended rather than becoming trapped between the water resistive barrier and the sheathing.

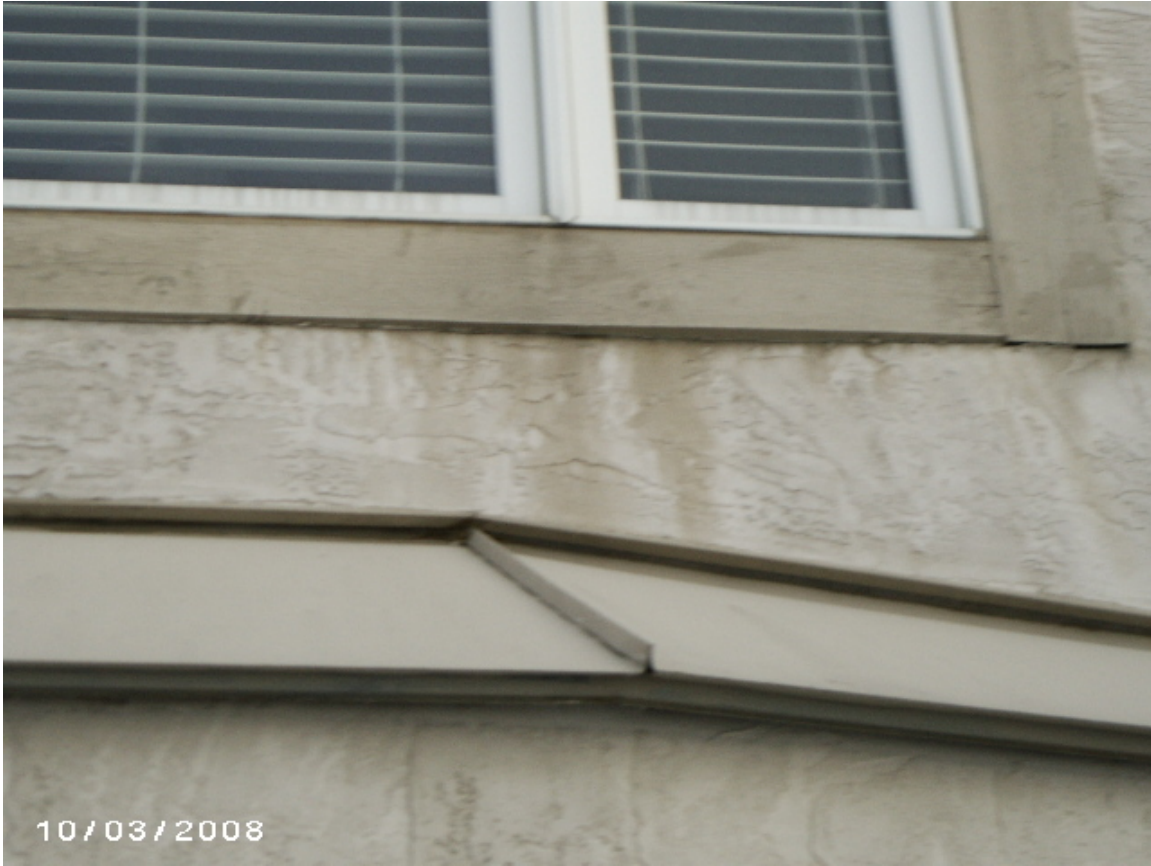
Unfortunately it is nearly impossible to determine if the window is flashed properly after the stucco has been installed. Sometimes the only clues visible are stains at the stucco trim junctions.

Builders and stucco contractors who are not informed regarding stucco failures will often consider this to be normal. They do not understand that water running down the window frames is becoming trapped behind the trim. The trim which is often not back primed allows water to rot not only the trim but to degrade the water resistive barrier behind it.

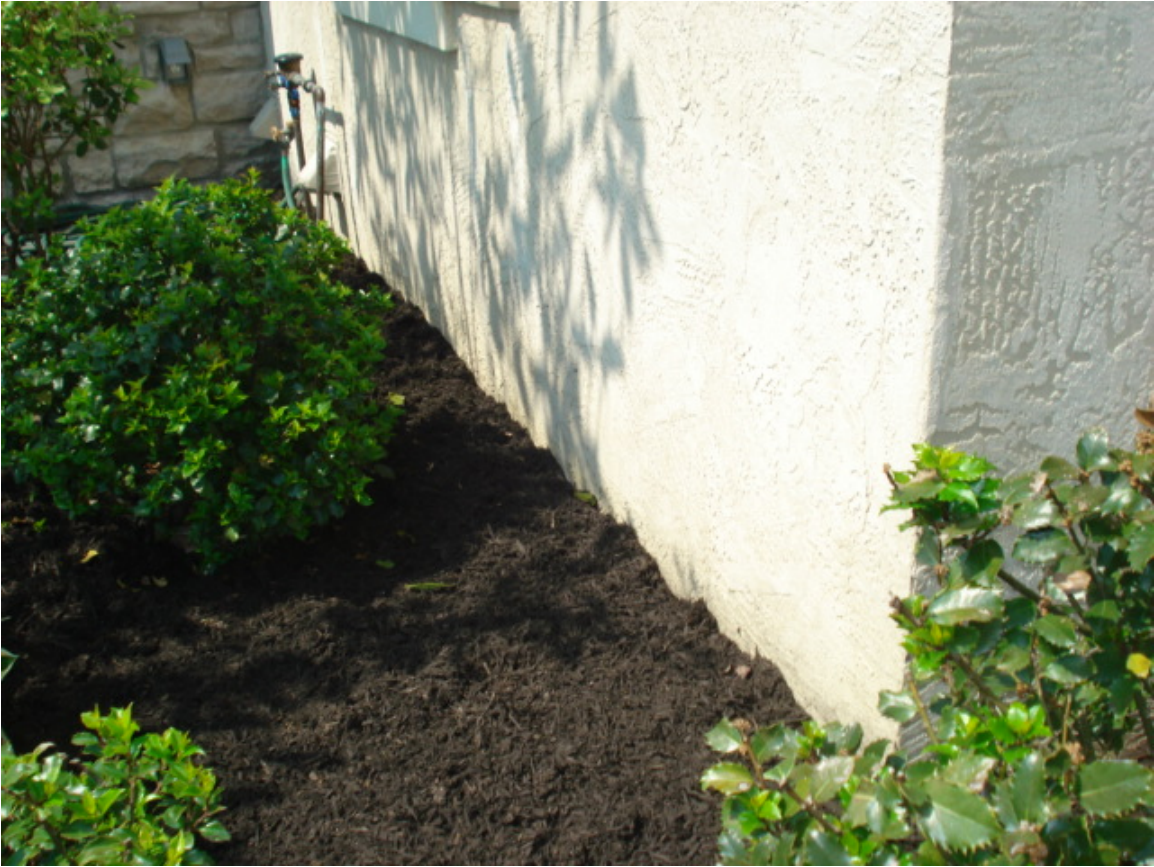
A weep screed is a termination accessory which receives the stucco at the base of the wall. It is a perforated metal channel which allows water which saturates the stucco to drain by gravity out of the system. Oftentimes the weep screed is omitted entirely and the stucco or cultured stone is allowed to terminate directly into the ground. This creates a condition whereby water will wick up the stucco by capillary action and eventually enter the wood sheathing at the base of the building. There should be a minimum clearance of 4 inches from the earth and 2 inches above sidewalks and patios.

In this example the home owner had been complaining about mold growing along the rim joist behind the insulation where the floor structure meets the foundation wall. The builder was called back out and concluded that the problem was due to the colder temperature of the rim joist. They elected to spray foam insulation in order to keep warmer house air from coming in contact with the colder wood.

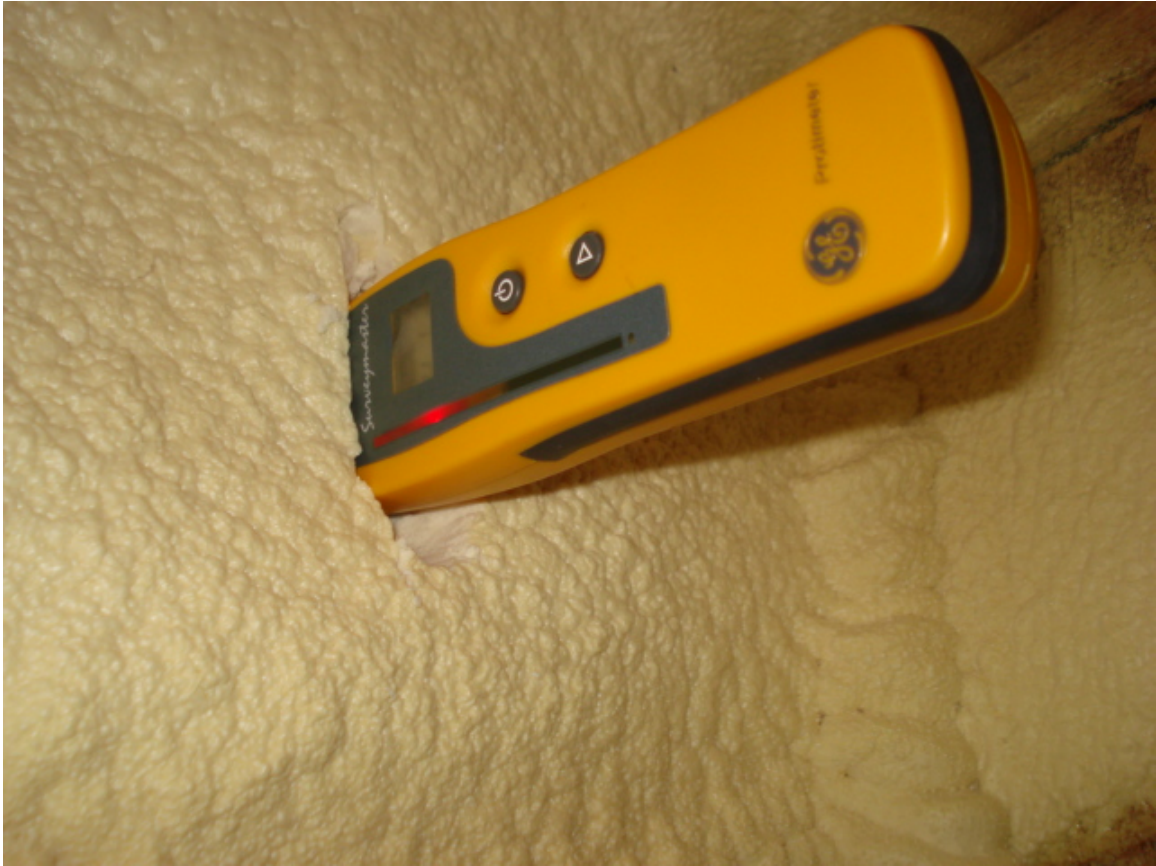
When a pin type moisture meter was inserted into the wood, moisture contents well above 20% were observed. The insulation was merely concealing the true problem, the lack of a weep screed and the dirt to stucco contact.

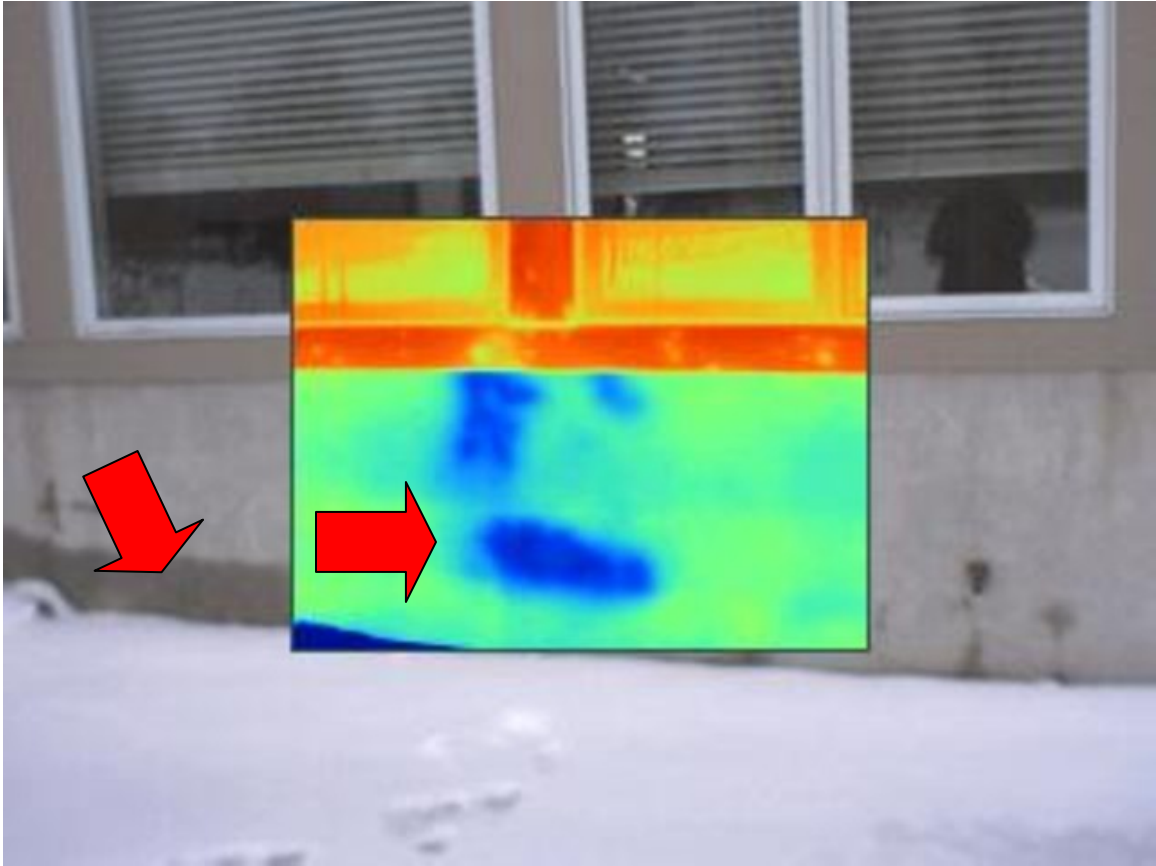
An infrared camera can be used effectively to observe where water may be saturating the stucco and ultimately the sheathing.

In this case the windows were leaking. One can also see how the stucco has absorbed moisture front the ground due to the lack of a weep screed and required clearance from the concrete patio. While infrared can be a useful tool conditions must be right for use. Generally the best circumstances are about 48 hours after a heavy saturating rain. Conditions can be simulated on a limited basis with a spray rack.

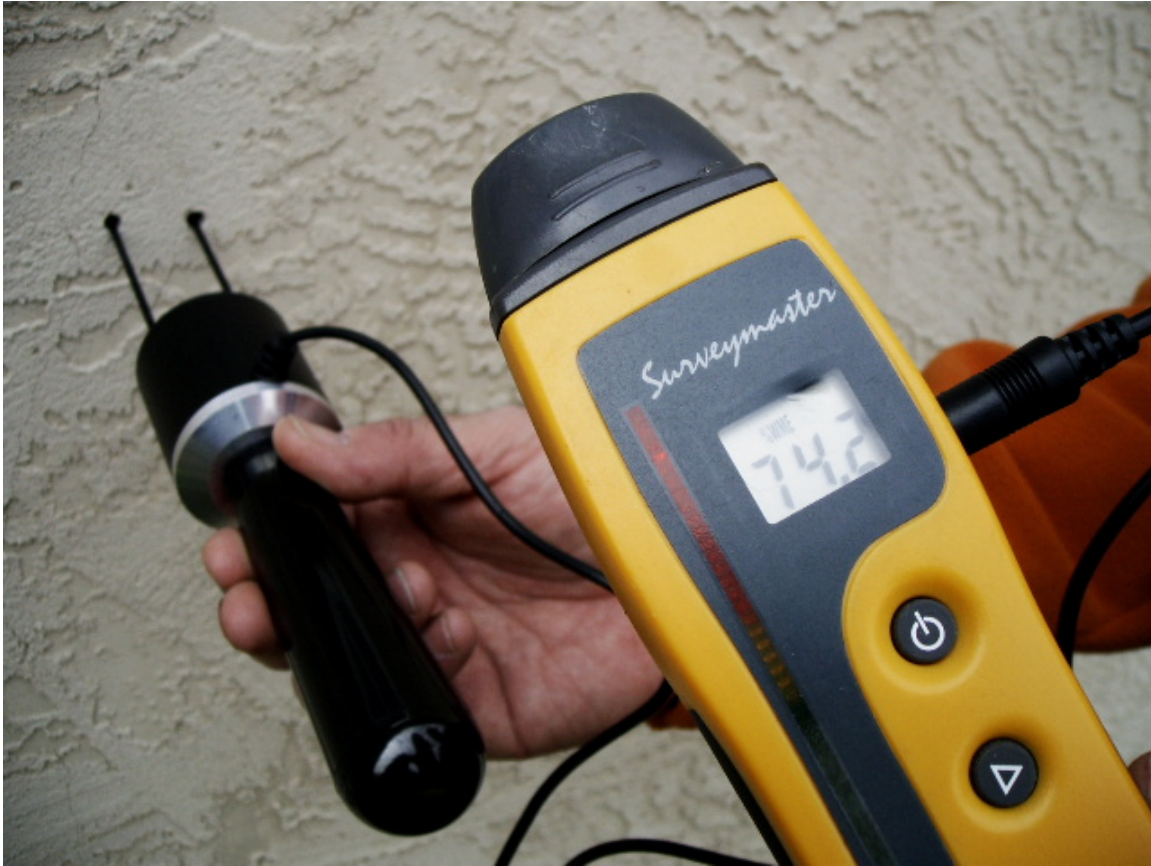
Ultimately the areas which have been identified in the infrared scan must be investigated further either with a moisture meter or by removing stucco. In this case moisture contents in the OSB sheathing were measured at 74.2%. Sustained levels of moisture above 20% will result in rot and deterioration.
